Billy Bishop Museum

Architectural Tour

The Bishop family home was built in 1884 using a popular style of architecture known as *Queen Anne Revival* (1870-1910).

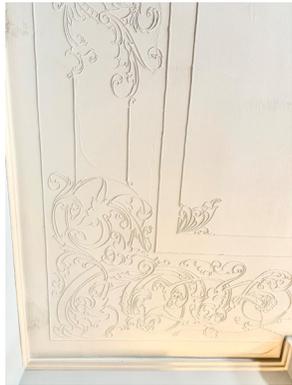
The raised “*art nouveau*” décor on the parlour ceilings is known as Tube Plastering, and was likely a later addition to the house. Tube Plastering or known in this area as “Miller Work” was a very popular and expensive European addition to grand Victorian homes from 1895 to 1905.

The elaborate plaster decoration on the ceiling of the dining room above the chandelier is known as an *escutcheon*. It is purely decorative and serves no useful function. The ceiling in the dining room was probably originally painted with elaborate designs.

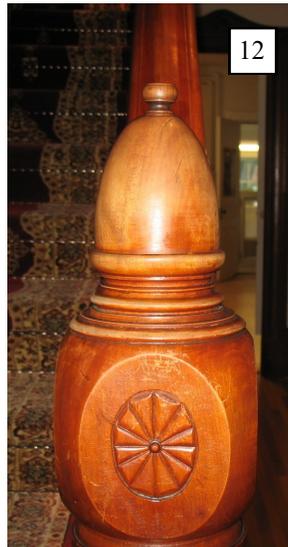
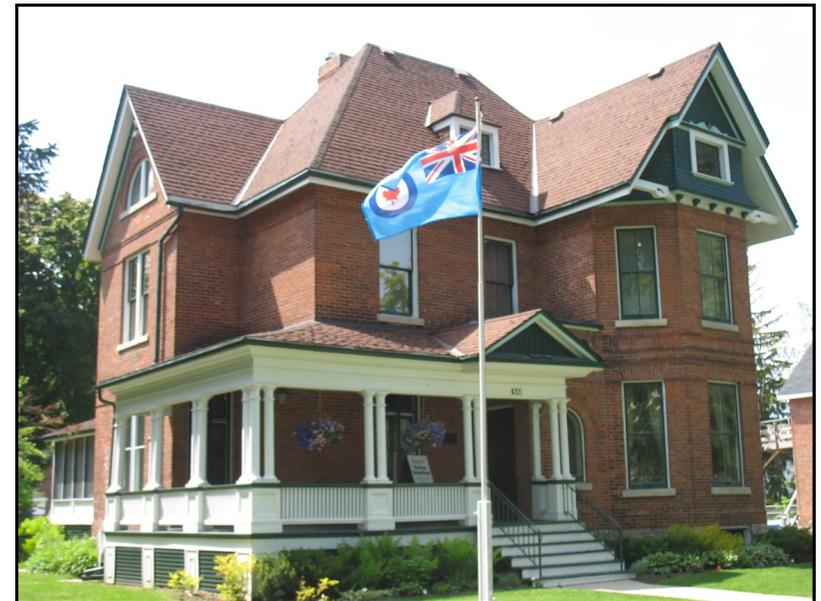
The railings of the main staircase have details such as the *drop acorn* decoration (12). The inserted factory pieces help create the curve in the banister near the top and add beauty to the staircase.

The servant’s quarters are located to the rear of the house (now office space). The very steep maid’s stairway, at the rear of the house is known as a *Winder*.

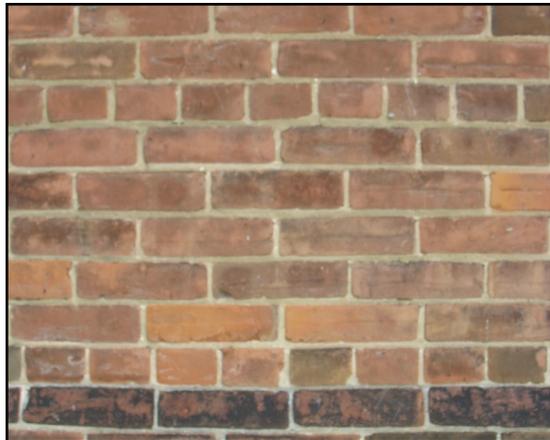
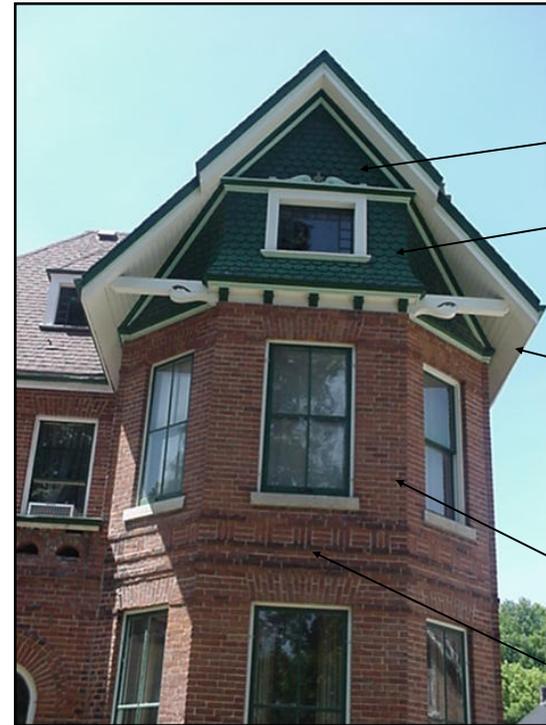
The elaborate decoration located above the attic window on the front bay is known as a volute (1). This detail resembles a classical 18th century china cabinet molding. The window (like the other attic window to the left) has a border around it, made up of smaller square windows. This too is typical Queen Anne style.

The *thrust gable* at the top of the front bay (4) has green *fish scale shingles* (2). The curvature of the front bay tower is a *French Empire* architectural detail.

The overhanging roof shades the projecting octagonal bay of the home. Two ornate gable brackets (3) secure the roof eaves firmly.

This would have been done to save time and money during the construction of the house. Pieces of projecting masonry, known as *string courses* (5 & 6) add a decorative touch.

The front of the house includes a large stained glass window. Above this window are three, Romanesque *splayed arches* (7). The *splayed arch* is characterized by a flat row of brick laid over the series of arches (a flat arch).

The window itself (9) is gothic or medieval in form. It is made of leaded stained glass, and was repaired in 2020. The same as rectangular stained glass windows over the dining room and office doors (now windowed). A metal bar (seen inside the house), placed near the center of these windows help to strengthen and support them.

Verandas on a typical Queen Anne style home are usually not this large. The columns along the veranda are known as modified *Tuscan Columns* (10) and are quite plain compared to other columns that have been created throughout history. Note the two combinations—three columns on the front ends, and the others paired (photograph on cover). The columns (entasis) are designed to bulge out slightly in the center.

The windows on the house are decorated with a series of brickwork around the edges, known as a *drip mold* (8), a Romanesque detail. The bricks that form the *drip mold* are shaped to form an arch over the windows. This would have been fairly expensive. The arches over the windows would usually have been formed by mortar rather than shaping the bricks to fit as the Bishop family had done.

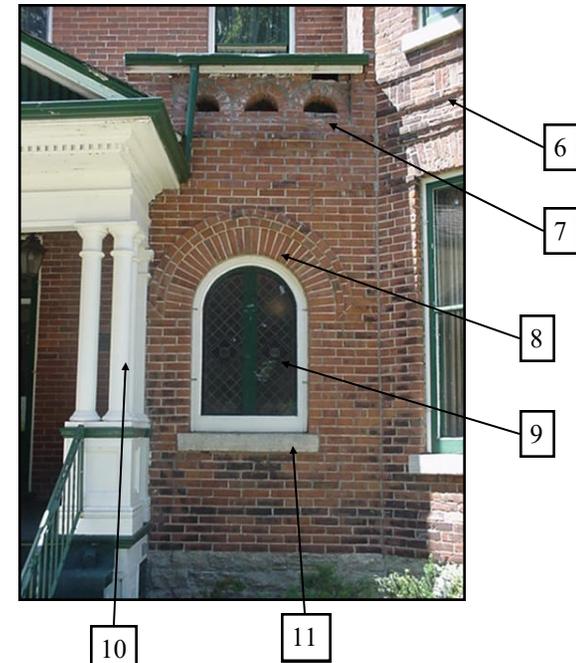
There are three distinct window patterns on the south tower. From the top down, the windows are a *Lunette Arched Window*, a *Flat Arched Window* and a *Segmental Arched Window*. This wide variety of window shapes and decorative brickwork exemplifies the Queen Anne style of architecture. Topped limestone windowsills (11) are also for decoration. The windows are known as stock and trade windows—fairly common for the time period.
